THERMAL CLEARANCE TESTING OF THE CHARNWOOD AIRE 3 FREE-STANDING APPLIANCE

Report Number: ASFT20113-1 Issue date: 15 December 2020

The Charnwood Aire 3 Free-standing appliance installed with a Room Seal Flue Kit was tested in two positions in a manner conforming to joint Australian/New Zealand Standard 2918:2018, Appendix B.

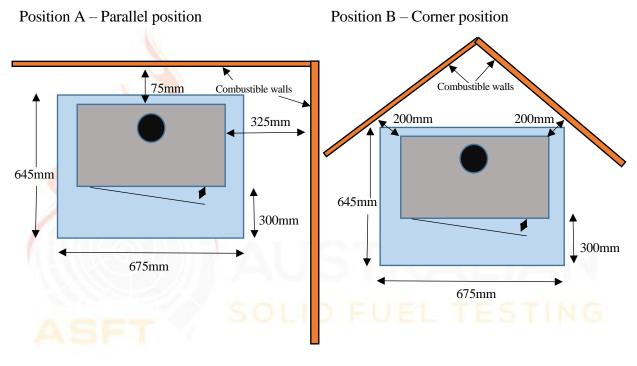
Figure 1 – Clearance Diagram

The appliance and flue system were tested at the following clearances:

The Charnwood Aire 3 Free-standing appliance installed with a Room Seal Flue Kit, conforms to the requirements of Australian/New Zealand Standard 2918:2018, with respect to floor, ceiling, side wall and rear wall surface temperatures, when tested in the test positions shown in Figure 1 of this report in accordance with Appendix B of AS/NZS2918;2018.

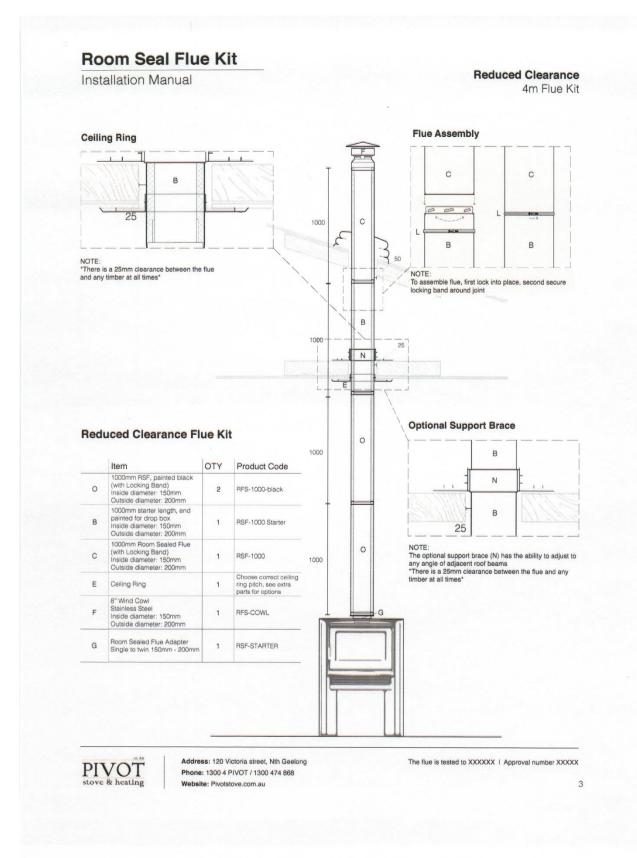
The flue system used during testing was a Room Seal Flue Kit with the Flue casing resting on the appliance top plate. Flue kit was supplied by Pivot Stoves & Heating Co. This flue system has been tested to joint AS/NZS 2918:2018, Appendix F. The flue height was 4.6 ± 0.1 m from the floor protector. Appendix 1 shows details of the flue system.
