THERMAL CLEARANCE TESTING OF THE CHARNWOOD ISLAND II FREE-STANDING APPLIANCE

Report Number: ASFT20109-1 Issue date: 16 December 2020

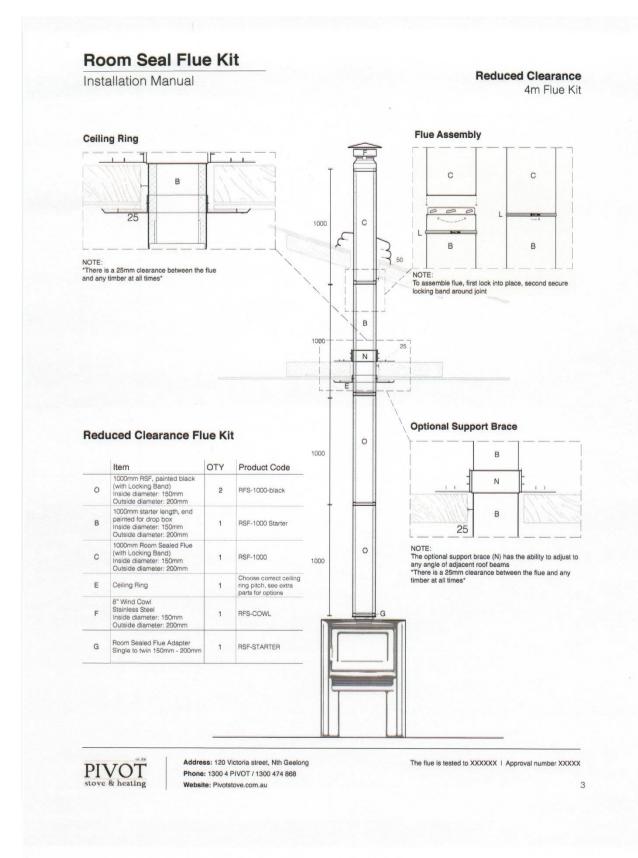
APPENDIX 1:

The flue system used during testing was a Room Seal Flue Kit supplied by Pivot Stoves & Heating. This flue system has been tested to joint AS/NZS 2918:2018, Appendix F. The flue height was 4.6 ± 0.1 m from the floor protector. Appendix 1 shows details of the flue system.
